DEPARTMENT OF TRANSPORTATION

Contract #: 04-0120F4Cty: SF/ALA Rte: 80 PM: 13.2/13.9File #: xx.28**WELDING INSPECTION REPORT****Resident Engineer:**Siegenthaler, Peter**Address:** 333 Burma Road**City:** Oakland, CA 94607**Report No:** WIR-020839**Date Inspected:** 21-Jul-2010**Project Name:** SAS Superstructure**OSM Arrival Time:** 700**Prime Contractor:** American Bridge/Fluor Enterprises, a JV**OSM Departure Time:** 1900**Contractor:** Zhenhua Port Machinery Company, Ltd (ZPMC), Changxing Island **Location:** Shanghai China**CWI Name:** Mr.Liu Huajie.**CWI Present:** Yes No**Inspected CWI report:** Yes No N/A**Rod Oven in Use:** Yes No N/A**Electrode to specification:** Yes No N/A**Weld Procedures Followed:** Yes No N/A**Qualified Welders:** Yes No N/A**Verified Joint Fit-up:** Yes No N/A**Approved Drawings:** Yes No N/A**Approved WPS:** Yes No N/A**Delayed / Cancelled:** Yes No N/A**Bridge No:** 34-0006**Component:** OBG Trial assembly**Summary of Items Observed:**

WELDING INSPECTION REPORT

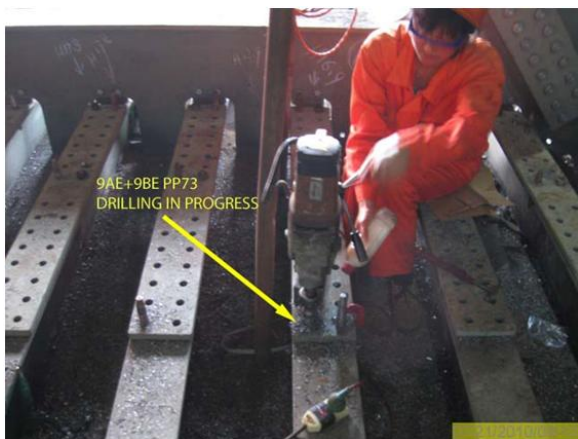
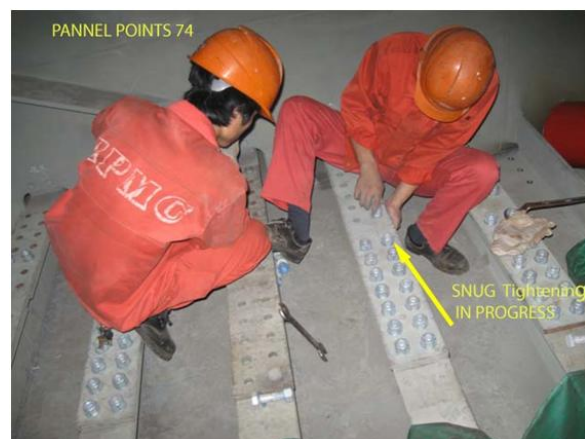
During surveillance Inspection we found 9AE+9BE Panel points 73 holes drilling activity was in progress And Snug Tightening was in progress at panel points PP74.

Flux Cored Arc Welding (FCAW) welding of Buildup for welds joint LD18C, And Welding Repair Report (WR) B-WR14077, and Welder is identified as 051246; ZPMC Quality Control (QC) is identified as Mr. Liu Huajie. The welding variables appeared to comply with the Applicable WPS-345-FCAW-1G (1F)-REPAIR-1.

Shielded Metal Arc Welding (SMAW) welding of welds joint SEG054C-001, SEG054B-024(9CE+9DE). Welder is identified as 053742. ZPMC Quality Control (QC) is identified as Mr. Liu Huajie. The welding variables appeared to comply with the Applicable WPS-B-T-2232-TC-U4b-FCM, /WPS-B-T-2233-TC-U4b-FCM.

SMAW welding of weld joint SEG052A-045, SEG054A-014(9BE-9CE), And Critical Welding Repair Report (CWR) B-CWR-1679-1, Welder is identified as 067571. ZPMC Quality Control (QC) is identified as Mr. Liu Huajie. The welding variables appeared to comply with the Applicable WPS-345-SMAW-4G (4F)-FCM-REPAIR-1.

Unless otherwise noted, all work observed on this date appeared to be in general compliance with the applicable contract documents.
